SERVICE BULLETIN

Inverted Coaster BATMAN THE RIDE

Six Flags Great Adventure

LIST OF MANUFACTURER'S NOTICES

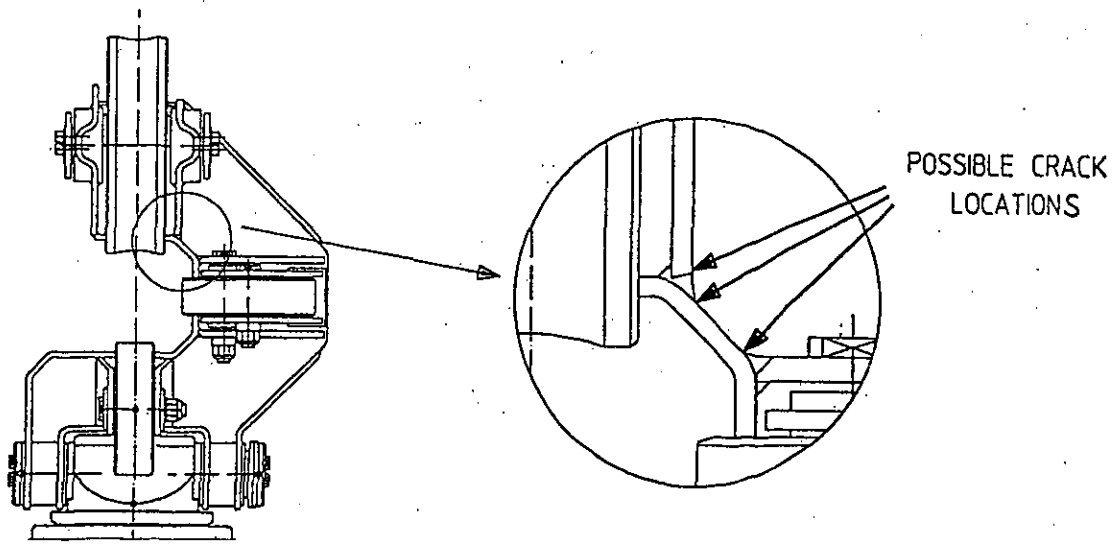
⇒ **Boggie**

1) We draw your attention to the fact that cracks were found on one Inverted Coaster on following components:

2) Accordingly, we ask you to carefully visually check daily:

- a) Remove the crack by grinding
- b) NDT inspection to make sure that the entire crack is removed
- c) Weld using a process adequate for ASTM A36 steel
- d) NDT inspection of the weld

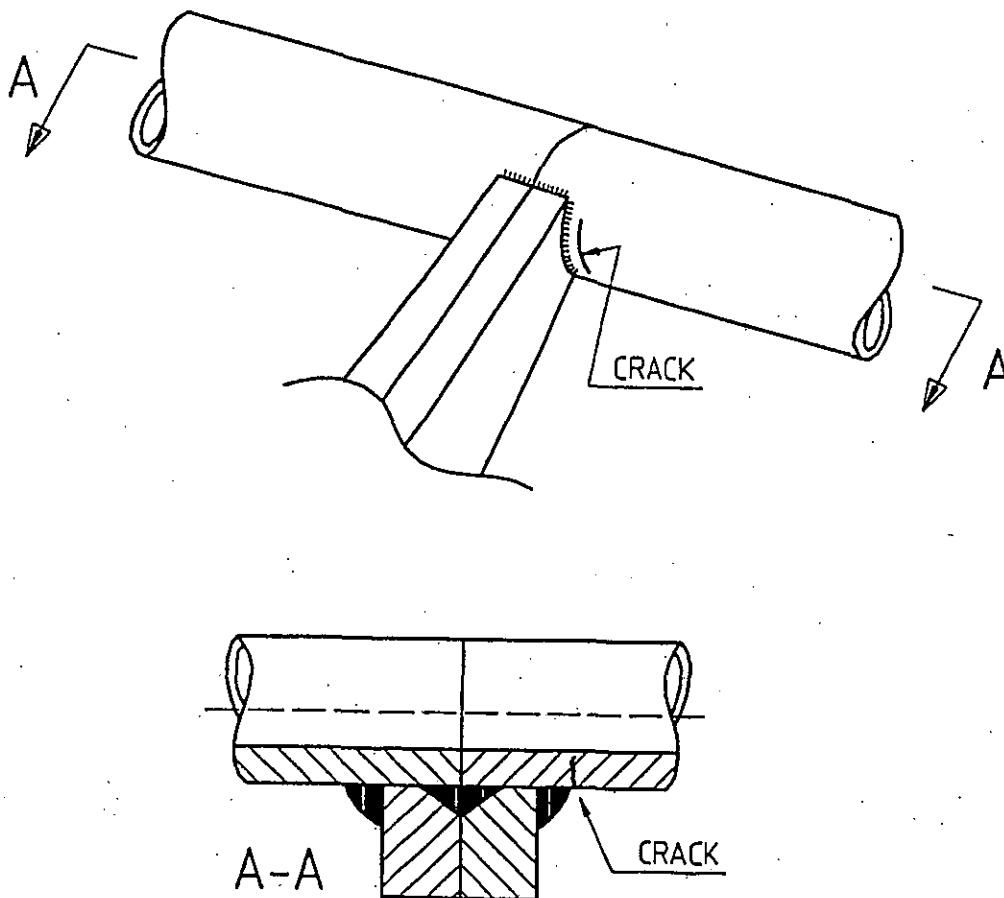
- 1) We draw your attention to the fact that cracks were found at a limited number of connections "rail - flange" on four coasters.

On three coasters, cracks were related to displacement of foundation.

- 2) Accordingly, we ask
- a) to carefully visually check any motion of the foundations while the train is operated.

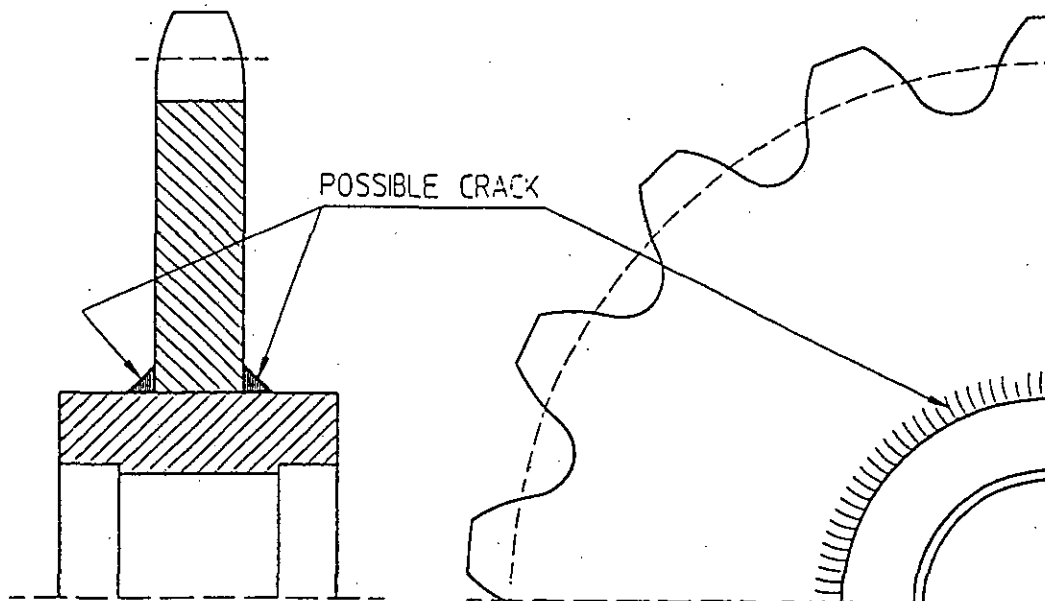
We draw your attention to the fact that cracks were found on one of our coasters on the center hub weld of the lift chain sprockets:

A total failure of such weld would cause severe damage at the lift chain.

Accordingly, we ask you to carefully visually check, every three months, the center hub welds of all lift chain sprockets, namely:

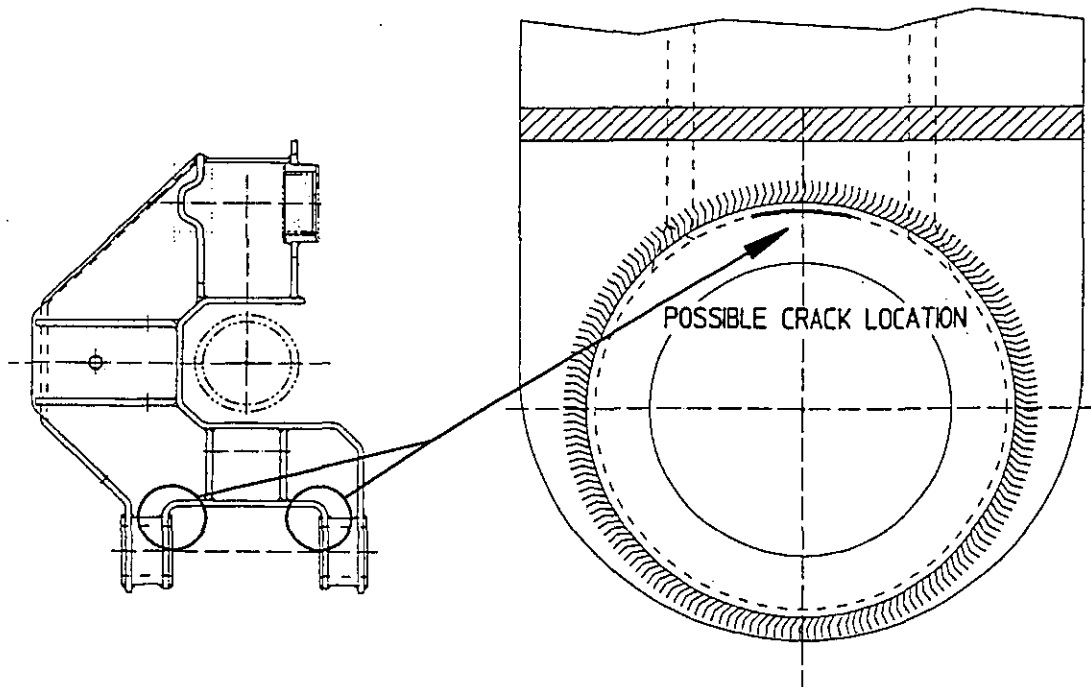
- 1) We draw your attention to the fact that cracks were found on the bogies of one Inverted Coaster. The location of those cracks is shown below :

- 2) We recommend to inspect the possible crack location once a year with magnaflux or dye penetrant. It is necessary to dismantle the bogie to conduct this inspection.

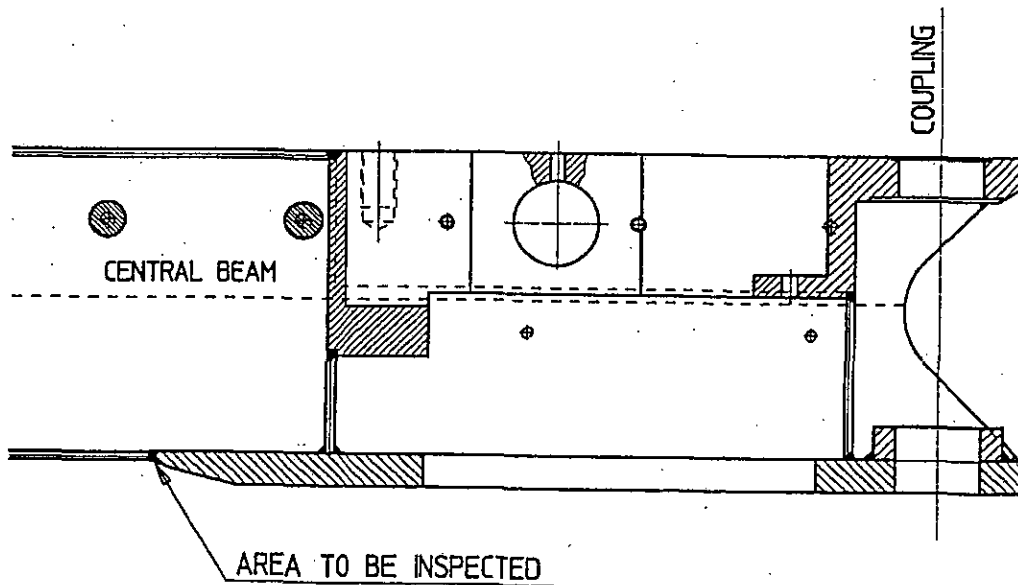
- 1) We draw your attention to the fact that cracks were found at the extremity of the bolted connection of the central beam of the coaches on one B&M ride.

- 2) Accordingly, we ask you to inspect these connections as follows:
 - a) immediate visual inspection, then
 - b) weekly visual inspection.

- 3) If any crack is found, the crack needs to be repaired before being further operated.

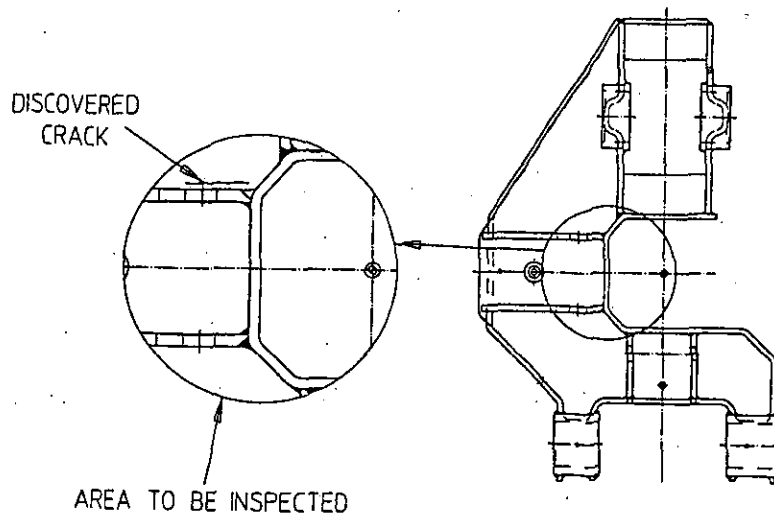
- 1) We draw your attention to the fact that cracks were found on one Inverted Coaster on five bogies in the area shown below.

- 2) Accordingly we ask you :
- a) to inspect with Magnaflux the area shown above
- before starting the new season
 - at mid season.

- b) to inspect visually once a week the area shown above. Dismantling of the side wheels is not necessary, except if visual inspection seem to indicate a crack.

- 3) Bolliger and Mabillard shall be informed of any crack. Ride shall not be operated if cracks are found in the bogies.

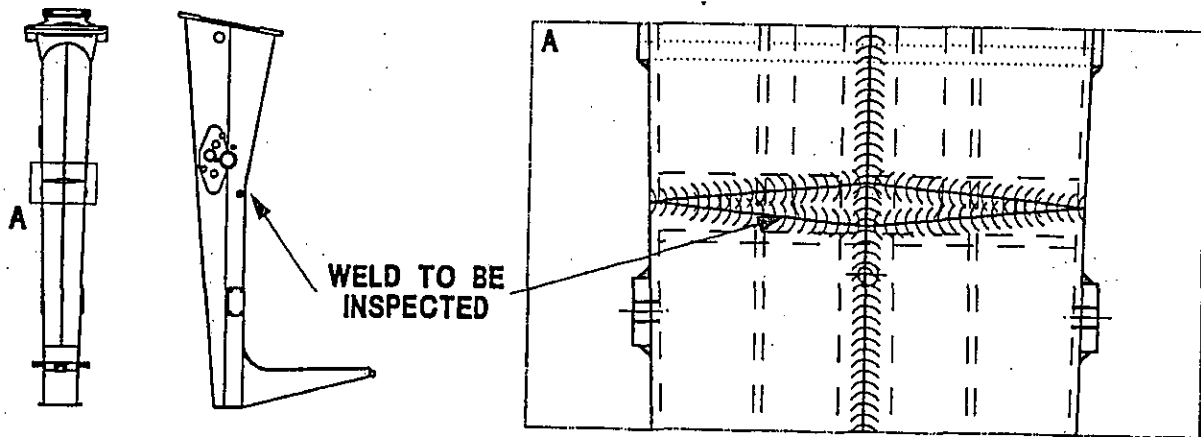
- 1) We draw your attention to the fact that cracks were found in the weld shown below, on seat columns of one B&M ride.

- 2) Accordingly, we ask you to inspect these connections as follows:
 - a) immediate visual inspection
 - b) magnetic particles inspection within 20 days
 - c) monthly visual inspection.

- 3) If any crack is found, no passenger shall be allowed on the seat where the crack was found before it is repaired.

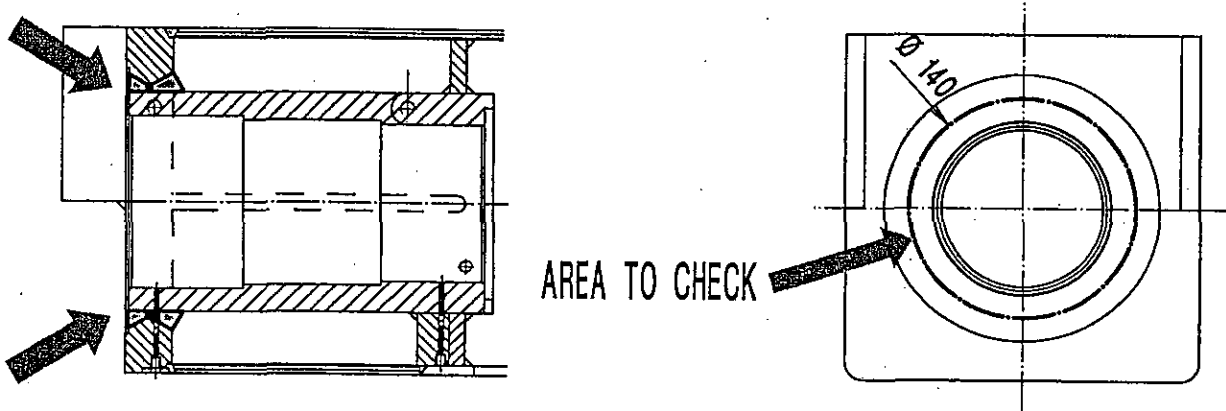
1. We draw your attention to the fact that one crack was found in the weld between the end plate of the central beam and the pipe of the coupling receiver on a B&M coaster.

THE AREA SHOWN ABOVE SHALL BE INSPECTED AT LEAST ONCE A YEAR AS FOLLOWS:

- a) dismantle the fork and the front thrust washer on each vehicle.
- b) magnetic particle inspection of the area shown above.
